# Manhole Inspection Summary

Manhole # S23K\_\_015MH

Insp Date: **6/11/08 7:27 AM**

**Location** Address: **351 S Mount St**

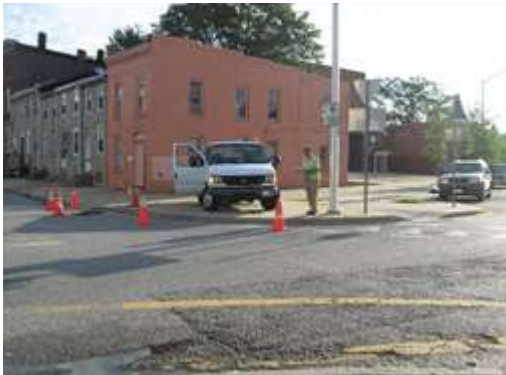
Location View

Comments **location of MH # 15 is differant then map on that location is a water meter. the MH is on the other side of the corner..**

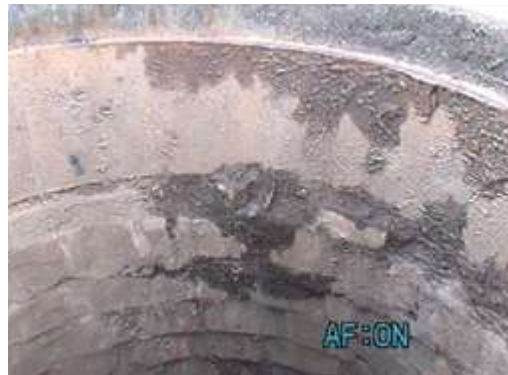
Miscellaneous

frame-lid infiltration

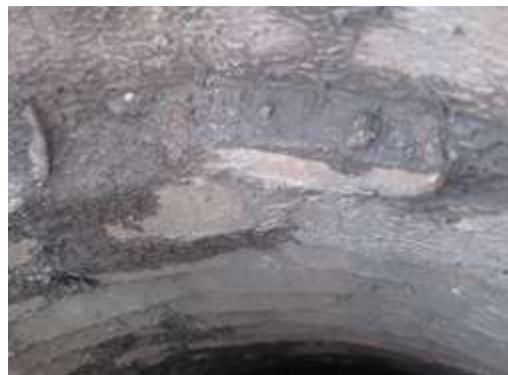
Defect 5

loose brick chimney,evidence of chimney infiltration

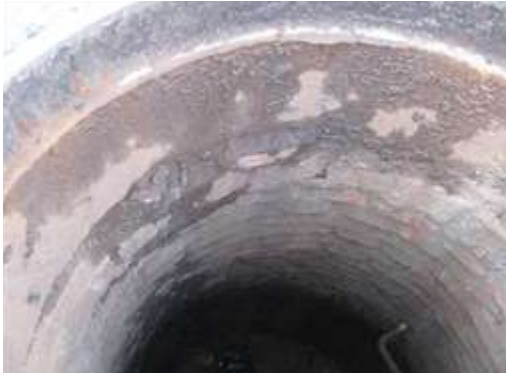
Defect 4

Condition: ☐ Sound ☐ Cracked ☒ **Leaks**

lid frame and chimney infiltration

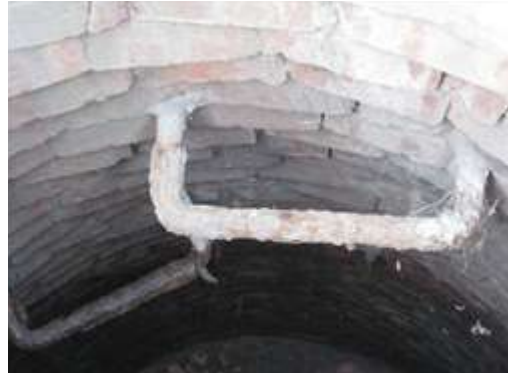
Defect 3

Count: **5** Missing: **3** ☒ **Corroded**

corroded rungs

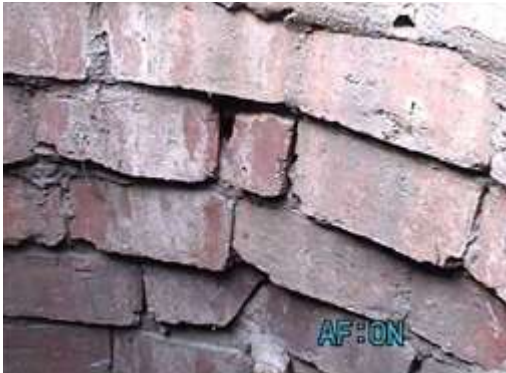
Defect 2

loose bricks and missing rungs in corbel

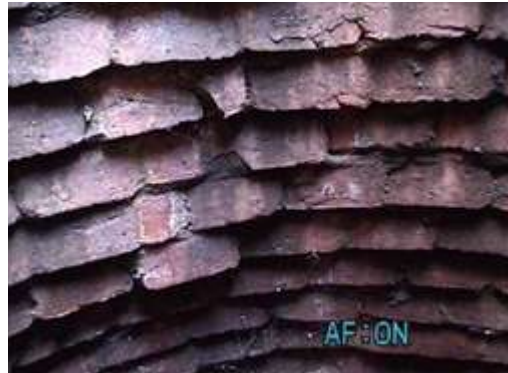
Defect 1

Condition: ☐ Sound ☒ **Cracked** ☐ Root Intrusion ☒ **Loose Brick** ☐ Deteriorated

cracked bricks, missing mortar, evidence of infiltration in corbel

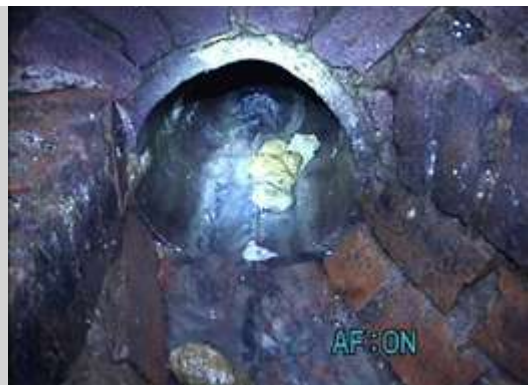
9 O'Clock Inflow

Infiltration: **Evidence** Pipe Seal Cond: **Broken**
